Custom WORM Flexible Temperature Sensor Solution Improves Accuracy and Safety at Ball Mill Mine

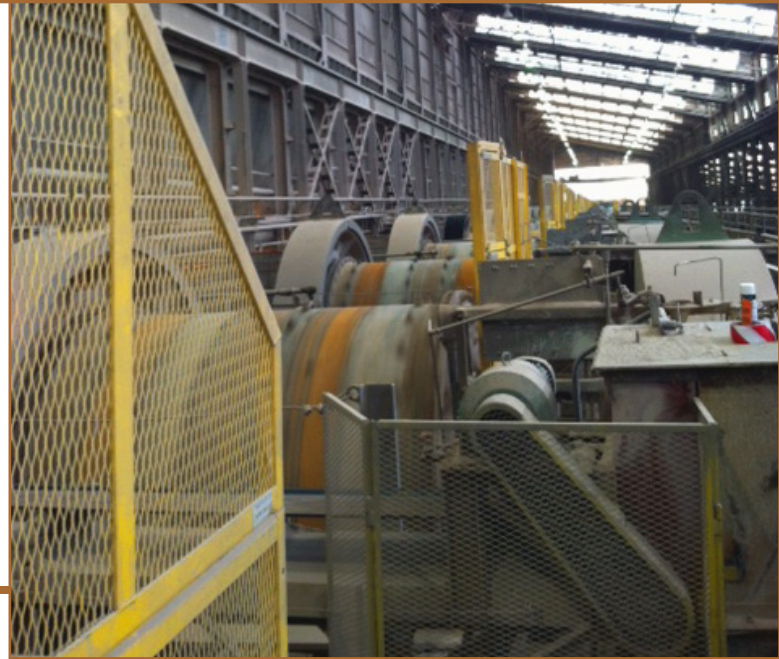
Figure 1. The WORM Flexible Temperature Sensors created for this installation include a specially-designed copper head that allowed the sensor to touch the bearings and draw heat to get the most accurate temperature readings possible.

Through a special installation of WORM Flexible Temperature Sensors from Moore Industries (Figure 1), site engineers are now able to more accurately measure the temperature of the bearings to avoid potential damages and shut downs. The installation also eliminated potential safety concerns at the mine.

Moore Industries' solution was to install the WORM Flexible Temperature Sensor. A specially-designed copper head was designed to ride on the bearings and measure their temperatures more accurately. This meant that an advance warning alarm could sound, alerting workers to add oil to the bearing tray to avoid burn out.

Why was copper selected as the material for the head of the temperature sensor? Copper is particularly effective because it acts as a heat sink, pulling heat from the bearings to the small WORM sensor. This provides faster responses and more accurate readings.

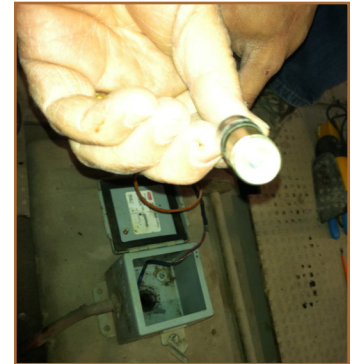
Figure 2. The older, non-contact I/R sensors which had previously been used at the mine. Because they were unable to get close to the ball bearings, they could only measure the ambient temperature near the bearing.

The method used was non-contact I/R sensors (Figure 2). The constant turning of bearings meant that sensors had to be mounted inches from the bearings. Because these sensors were not able to get close enough to the ball bearings, they primarily measured ambient temperature around the bearings. This sensor design inhibited detection of increases in temperature when the bearings began to overheat. The bearings frequently burned out by the time the reading caught up to the rise in actual bearing temperature.

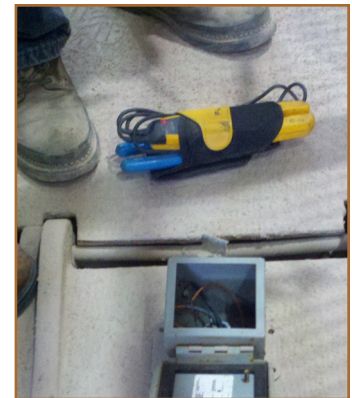
Figure 3. Old I/R sensors at the mine site were mounted in boxes that protruded several inches off of the ground.

Using the WORM also created a safer environment at the mine as well as saving money by preventing costly interruptions to the flow of the ore. The older I/R sensors were installed in boxes mounted to the floor of the catwalks just a foot above the ball mills. These boxes rose about six inches from the floor and were an extreme safety hazard to all passing employees (Figure 3). Personnel working around the mills walked on these catwalks and were in danger of tripping on these boxes – and potentially having a dangerous fall – or stepping on them and crushing the sensors.

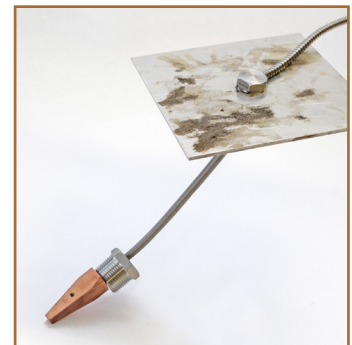
Figure 4. The installation of the WORM lays flat on the catwalks. This reduces the risk of accidents along with the chance that sensors can be stepped on and crushed.

By installing the WORM sensors, the site operators were able to eliminate the dangerous working environment caused by the sensors on the catwalk (Figure 4). They have a flat insulation, which means that they can be installed directly into the floor with a minimal and safer vertical profile.
