Custom WORM Flexible Temperature Sensor Solution Improves Accuracy and Safety at Ball Mill Mine

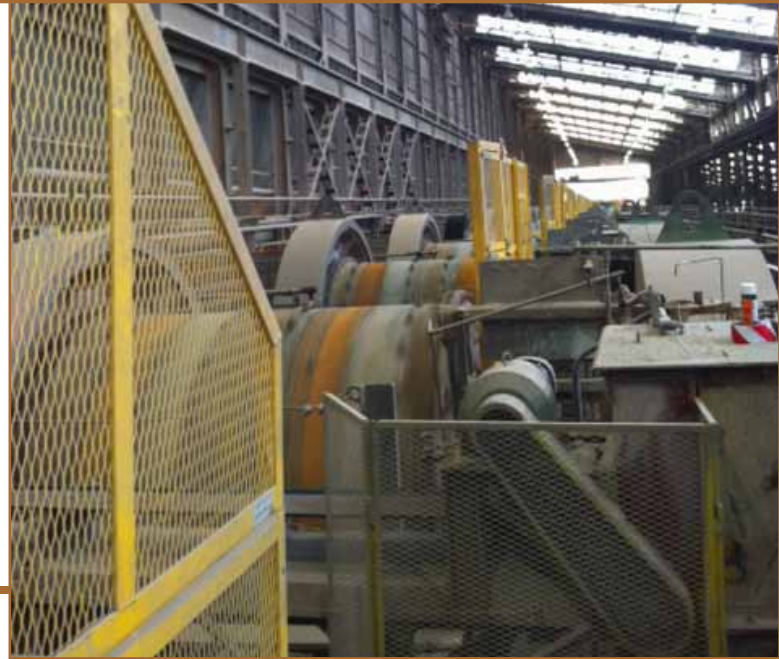
The process of extracting copper from raw ore at a large mine in southeastern Arizona involves using crushing rocks with mills with giant rocks (as seen in the photo above). Large ball mills are used in the extraction of copper from large boulders. These mills have large bearings attached to them, which heat up over time due to friction. If the bearing temperatures exceed critical levels, they can become damaged and shut down the entire process. The site originally used I/R sensors but they were unable to get close enough to the bearings to capture accurate ambient temperature readings, increasing the risk of a burn out.

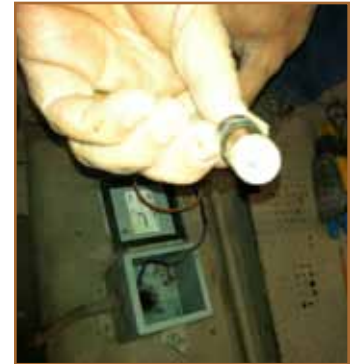
Figure 2. The older, non-contact I/R sensors which had previously been used at the mine. Because they were unable to get close to the ball bearings, they could only measure the ambient temperature near the bearing.

The method used was non-contact I/R sensors (Figure 2). The constant turning of bearings meant that sensors had to be mounted inches from the bearings. Because these sensors were not able to get close enough to the ball bearings, they primarily measured ambient temperature around the bearings. This sensor design inhibited detection of increases in temperature when the bearings began to overheat. The bearings frequently burned out by the time the reading caught up to the rise in actual bearing temperature.

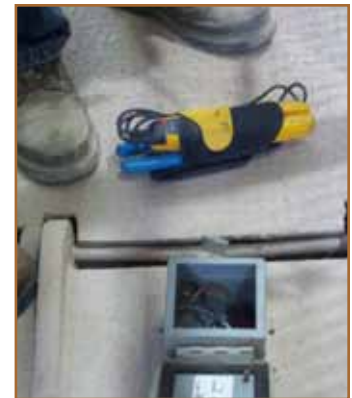
Figure 3. Old I/R sensors at the mine site were mounted in boxes that protruded several inches off of the ground.

Using the WORM also created a safer environment at the mine as well as saving money by preventing costly interruptions to the flow of the ore. The older I/R sensors were installed in boxes mounted to the floor of the catwalks just a foot above the ball mills. These boxes rose about six inches from the floor and were an extreme safety hazard to all passing employees (Figure 3). Personnel working around the mills walked on these catwalks and were in danger of tripping on these boxes – and potentially having a dangerous fall – or stepping on them and crushing the sensors.

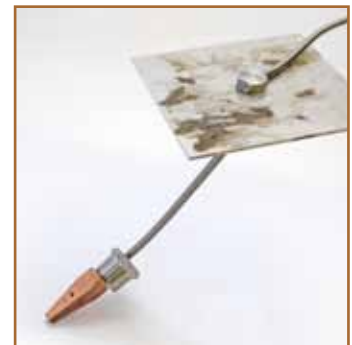
Figure 4. The installation of the WORM lays flat on the catwalks. This reduces the risk of accidents along with the chance that sensors can be stepped on and crushed.

By installing the WORM sensors, the site operators were able to eliminate the dangerous working environment caused by the sensors on the catwalk (Figure 4). They have a flat insulation, which means that they can be installed directly into the floor with a minimal and safer vertical profile.
