## Custom WORM Flexible Temperature Sensor Solution Improves Accuracy and Safety at Ball Mill Mine

Through a special installation of WORM Flexible Temperature Sensors from Moore Industries (Figure 1), site engineers are now able to more accurately measure the temperature of the bearings to avoid potential damages and shut downs. The installation also eliminated potential safety concerns at the mine.

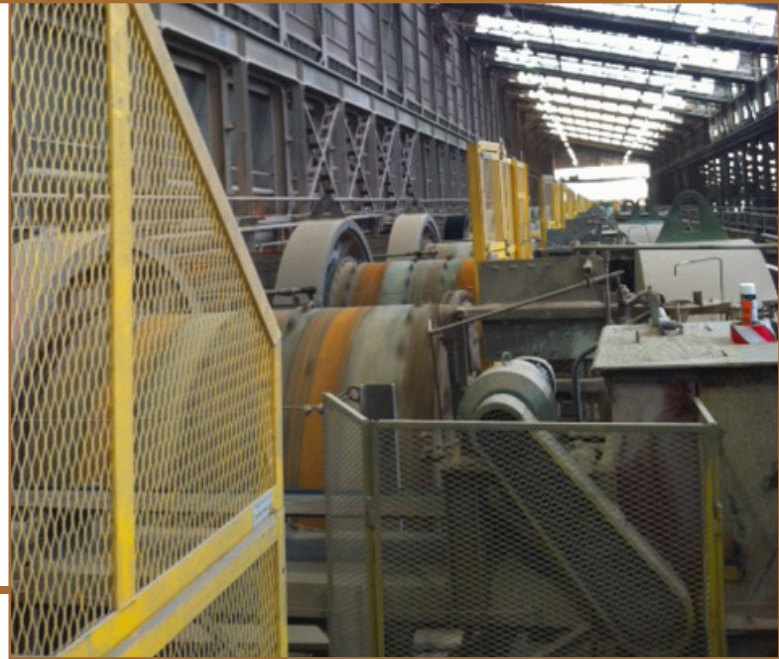
The process of extracting copper from raw ore at a large mine in southeastern Arizona involves using crushing rocks with mills with giant rocks (as seen in the photo above). Large ball mills are used in the extraction of copper from large boulders. These mills have large bearings attached to them, which heat up over time due to friction. If the bearing temperatures exceed critical levels, they can become damaged and shut down the entire process. The site originally used I/R sensors but they were unable to get close enough to the bearings to capture accurate ambient temperature readings, increasing the risk of a burn out.

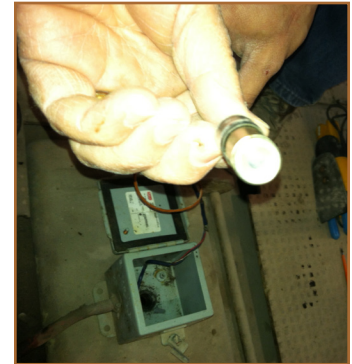
**Figure 2.** The older, non-contact I/R sensors which had previously been used at the mine. Because they were unable to get close to the ball bearings, they could only measure the ambient temperature near the bearing.

The method used was non-contact I/R sensors (Figure 2). The constant turning of bearings meant that sensors had to be mounted inches from the bearings. Because these sensors were not able to get close enough to the ball bearings, they primarily measured ambient temperature around the bearings. This sensor design inhibited detection of increases in temperature when the bearings began to overheat. The bearings frequently burned out by the time the reading caught up to the rise in actual bearing temperature.

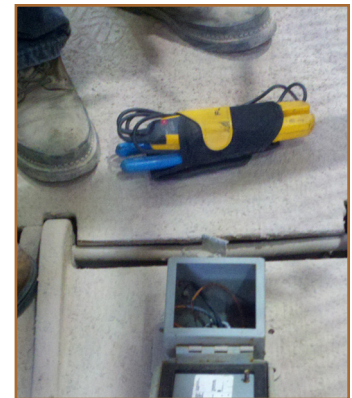
**Figure 3.** Old I/R sensors at the mine site were mounted in boxes that protruded several inches off of the ground.

Using the WORM also created a safer environment at the mine as well as saving money by preventing costly interruptions to the flow of the ore. The older I/R sensors were installed in boxes mounted to the floor of the catwalks just a foot above the ball mills. These boxes rose about six inches from the floor and were an extreme safety hazard to all passing employees (Figure 3). Personnel working around the mills walked on these catwalks and were in danger of tripping on these boxes – and potentially having a dangerous fall – or stepping on them and crushing the sensors.

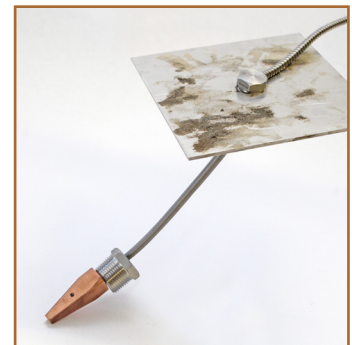
**Figure 4.** The installation of the WORM lays flat on the catwalks. This reduces the risk of accidents along with the chance that sensors can be stepped on and crushed.

By installing the WORM sensors, the site operators were able to eliminate the dangerous working environment caused by the sensors on the catwalk (Figure 4). They have a flat insulation, which means that they can be installed directly into the floor with a minimal and safer vertical profile.
